## SIPLAST*FLASH*

### **Issue:**

Water infiltration or rainwater penetration into lightweight insulating concrete (LWIC) roof insulation systems can lead to various moisture-related issues when attempting to bond roof membranes directly to the substrate without any venting mechanisms.. This technical bulletin provides guidance on identifying and addressing water infiltration in LWIC, as well as recommendations for removing moisture and the appropriate timing for installing the roof membrane.

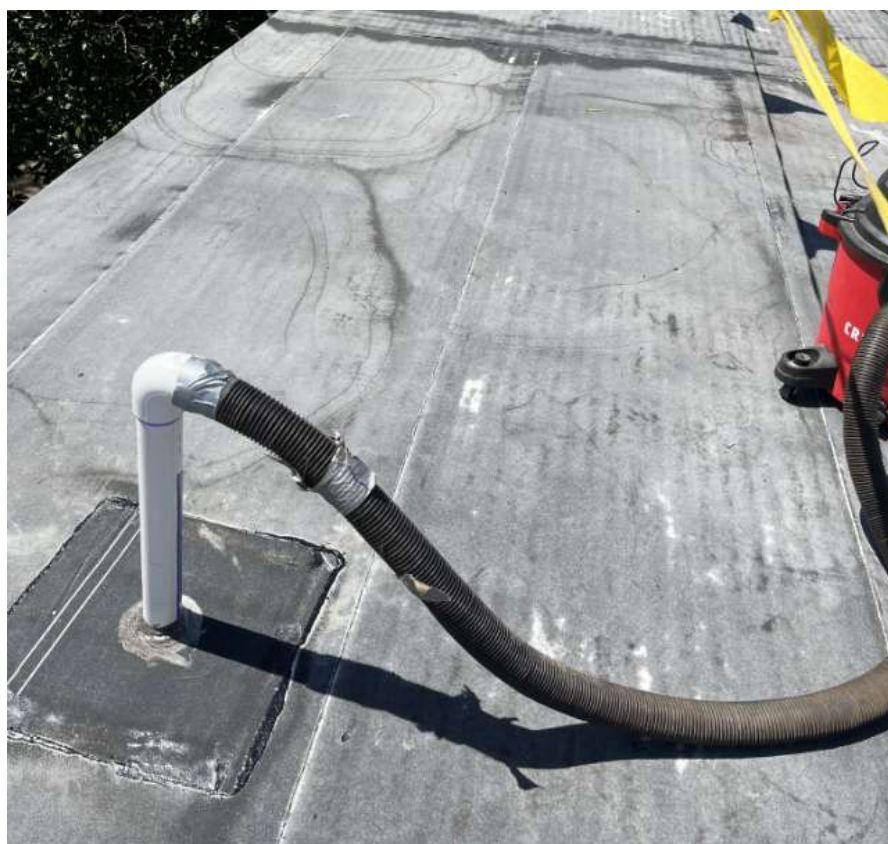
Ports will need to be cored or cut into the LWIC system to see if moisture is present in an area and if so, remove it by way of vacuum. Generally, these ports will need to be approx. 4" in diameter and cut through the LWIC down to the substrate. If a vapor retarder or sub-roof is in place, ensure it is not damaged in the process. These ports are cut-in similarly to how one-way vents are installed but are meant to be a temporary means for removing excess moisture. Once the excess moisture is removed these areas may be patched and roofed over as normal.
