Some Surprising Results: Wind Tunnel Testing of Low-Slope Edge Metal

Jim Kirby, AIA

Building Science, Industry Relations & Compliance

May 2023

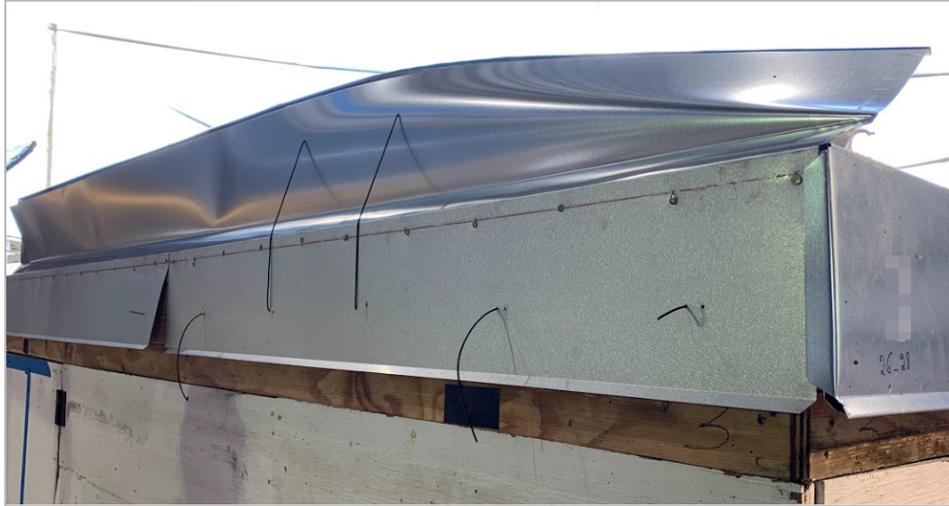
Each of the test decks was tested at multiple wind directions until the edge metal failed. For this research, "failure" was when the fascia flipped up and onto the roof. This photo is an example of failure, as defined for this research.

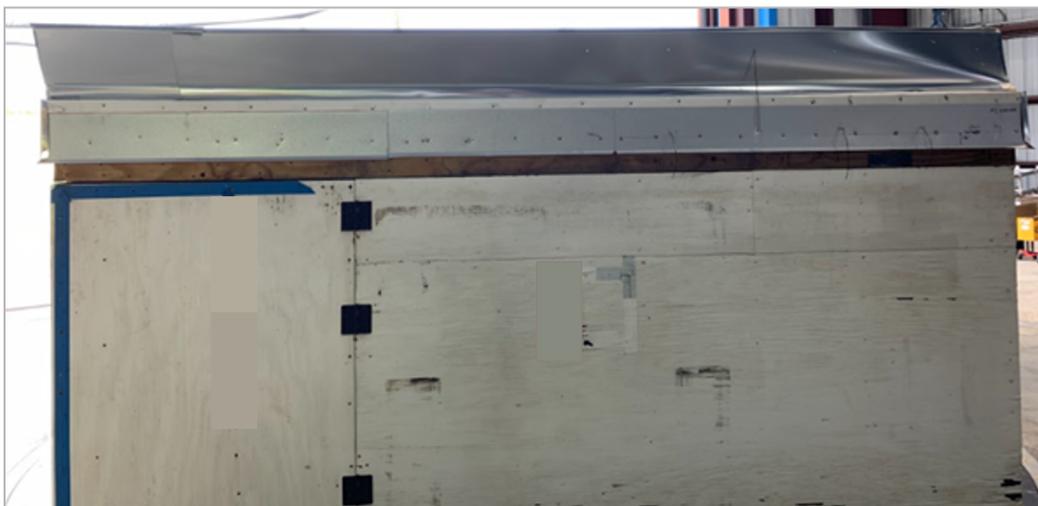
Configuration #1 (6" cleat, fastened 1 3/4" above the drip edge) failed at a relatively low wind speed: 77 mph. The failure was due to the fascia's drip edge disengaging from the cleat. Observation of the cleat showed the cleat-fascia disengagement at the low wind speed was due to the cleat being installed approximately 1/4" too high—an installation error. This mis-alignment reduced the drip-edge engagement significantly. Note that the cleat remains in place. The photo below shows the failure mode.

Because this was a research project, the installation of the edge metal was performed under ideal conditions. And yet, even under ideal conditions, the short cleat was positioned slightly incorrectly, which led to failure at low wind speeds due to the disengagement of the drip edge.

- Use L-shaped cleats. L-shaped cleats provide a way to ensure the fascia's drip edge is properly aligned with the cleat. This will help with quality control and quality assurance in the field. Configurations #3 and #4 used L-shaped cleats.

- Using longer drip edges (i.e., longer than $\frac{3}{4}$ ") will help increase the possibility of proper drip edge-to-cleat engagement; therefore reducing the possibility of cleat disengagement. This is especially true when the cleat is not self-aligning. Tom Smith recommended this in 1990 in a paper titled, "[Hurricane Hugo's Effects on Metal Edge Flashings](#)," from the International Journal of Roofing Technology, NRCA, Rosemont, IL.

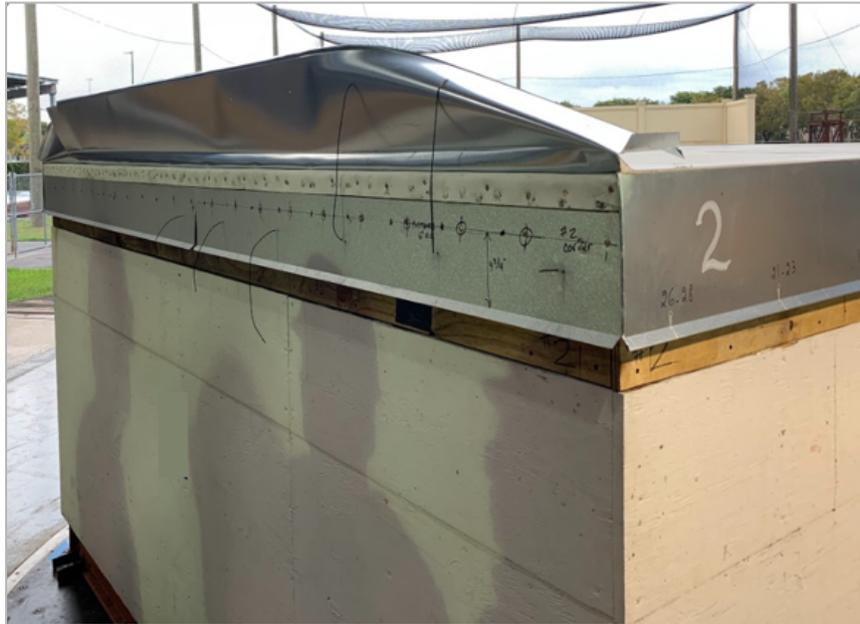
Configuration #2 (6" cleat, fastened 4 ½" above the drip edge) failed at 134 mph. There was some fluttering of the fascia near the corner at lower wind speeds. The failure was, again, the result of the disengagement of the fascia drip edge from the cleat. Note that the cleat remains in place. There was little outward permanent deformation of the fascia and cleat system until failure occurred. The photo below shows the failure mode.

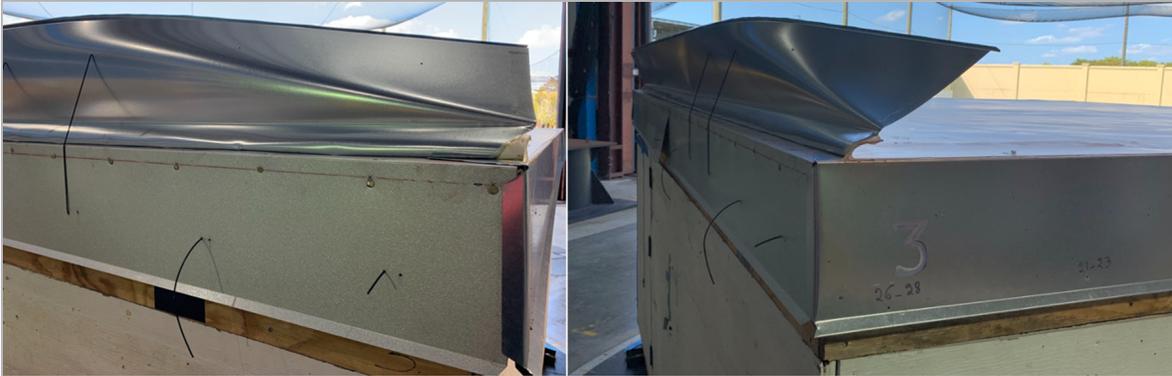
Configuration #3 (8" L-shaped cleat, fastened ¾" from the top edge of the vertical portion of the cleat into the face of the horizontal nailer) failed at 134 mph. Similar to configuration #2, there was some fluttering of the fascia near the corner at lower wind speeds. Again, the failure was the result of the fascia's drip edge disengaging from the cleat. The cleat generally remained in place; the cleat furthest from the corner had minimal permanent deformation (before failure occurred), but was deemed to remain able to perform. The 2 photos below show the failure mode.

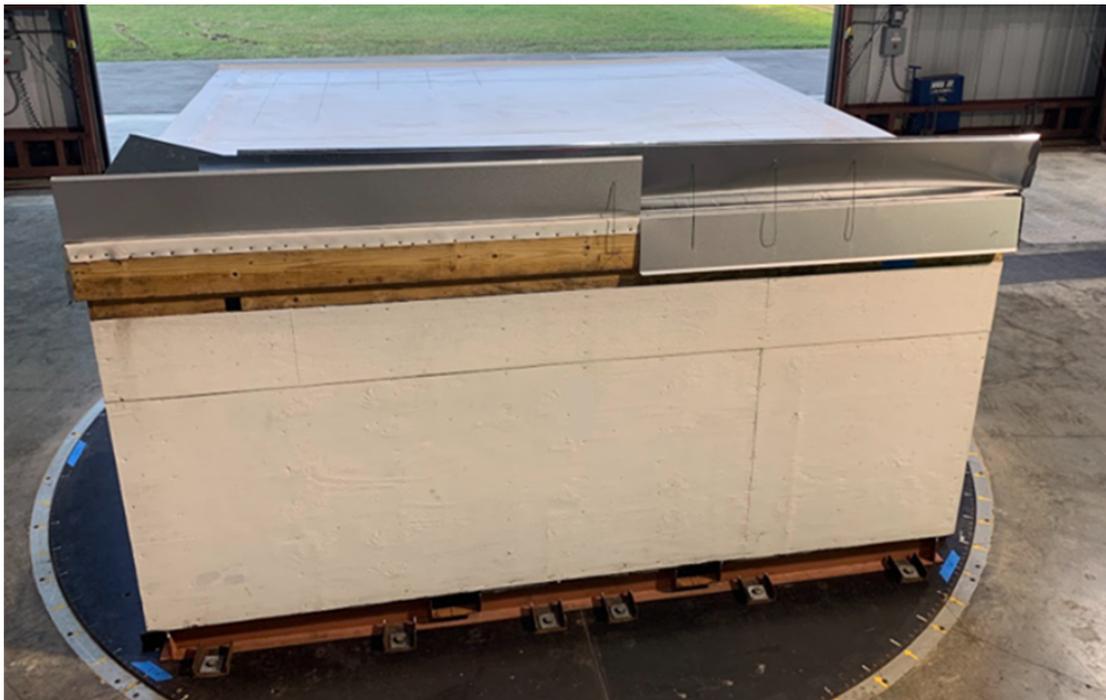
Configuration #4 (8" L-shaped cleat, fastened $\frac{3}{4}$ " from the outer edge of the horizontal portion of the cleat into the horizontal nailer) failed at 134 mph. This configuration began to flutter at relatively low wind speeds. This is not surprising given the vertical portion of the cleat was not fastened. Fluttering increased as wind speeds increased. This configuration had more outward permanent deformation than the other 3 configurations (before failure occurred); again, this was not surprising given the location of the fastener. The failure mode was two-fold; the nearest-to-the-corner portion failed due to the fascia disengaging from the cleat. And, the furthest-from-the corner portion failed because the fascia and cleat flipped up and onto the horizontal portion of the roof. The fascia and cleat did not stay together, so it is unknown if the cleat disengaged first or if the fascia-cleat flipped up together first. Regardless, where the cleat flipped up, the roof edge is exposed to potential weather infiltration. The photo below shows the failure mode.
