Diagonal Wrinkling (Racking) of Membrane Base Flashing

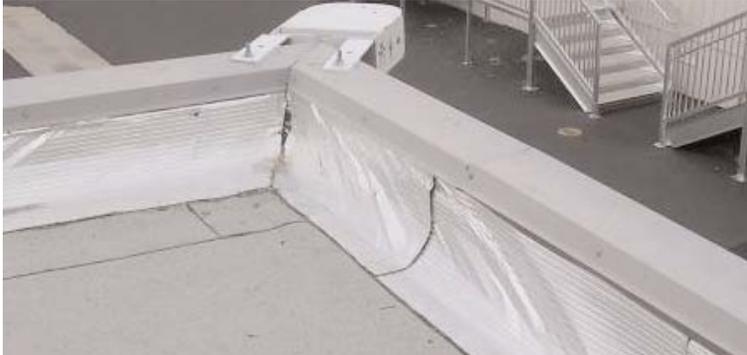
Siplast Veral - Aluminum-clad SBS-modified Bitumen

All roofing materials used for flashing walls adjoining the roof system can be affected by this type of differential building movement. Veral membrane flashing is no exception. The wrinkles can vary from small to large enough to pull the flashing membrane from the wall, open laps, and delaminate surfacings. Clearly, the roof/flashing membrane should be repaired when the materials are stressed to the point that the watertight integrity of the roof system could be compromised. Membrane damage caused by structural movement and movement of substrate components is typically not covered by membrane manufacturers' guarantees.
