Some Surprising Results: Wind Tunnel Testing of Low-Slope Edge Metal

Jim Kirby, AIA

Building Science, Industry Relations & Compliance

May 2023

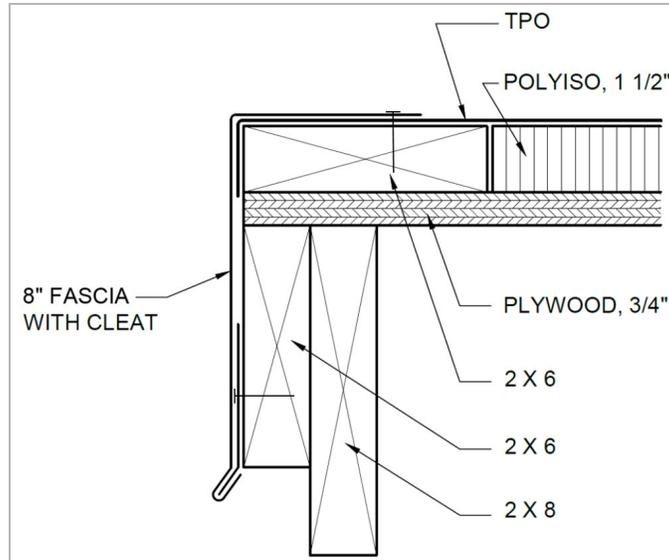
Full-scale wind tunnel testing was performed at FIU's Wall of Wind (WoW) in February 2022. Four full-scale wind tunnel tests were performed using a contractor-fabricated, 24-gauge steel, L-shaped edge metal system with an 8 in. face, 4 in. horizontal flange, and ¾ in. drip edge. The horizontal flange of the fascia was fastened into the wood blocking. This figure shows the generic edge metal detail used in the research.

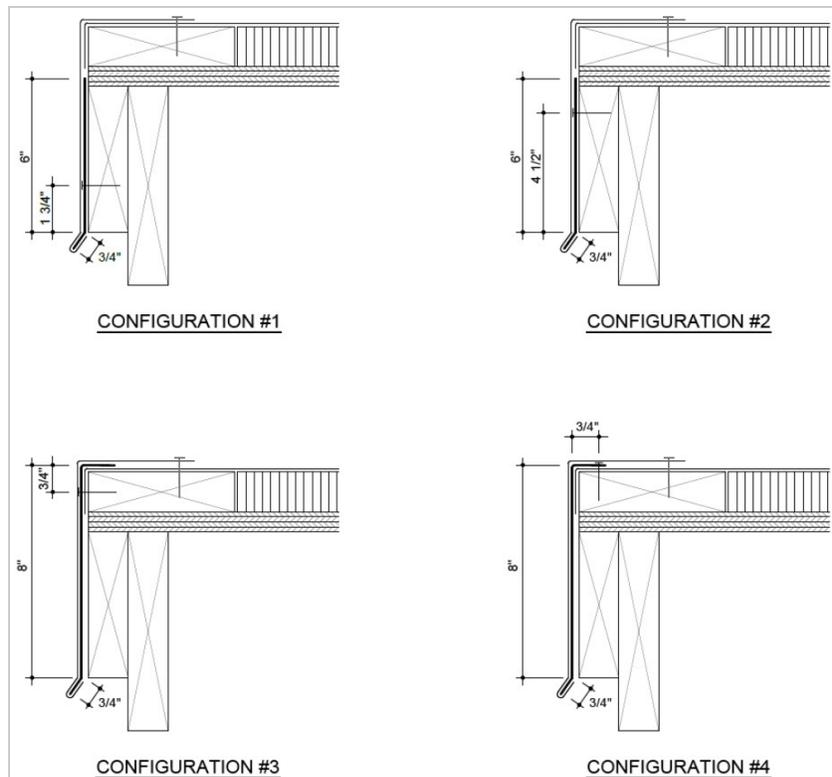
Two different 22-gauge steel cleat shapes were used—a 6 in. cleat and an 8 in. cleat with a 1 in. horizontal return (L-shaped cleats). Four different cleat-fastener locations were used—one low, one in the middle, and one high on the vertical surface, and one on the horizontal surface (Configurations #1, #2, #3, and #4, respectively). The figure below shows the 2 cleat shapes and 4 fastening locations used in this research.

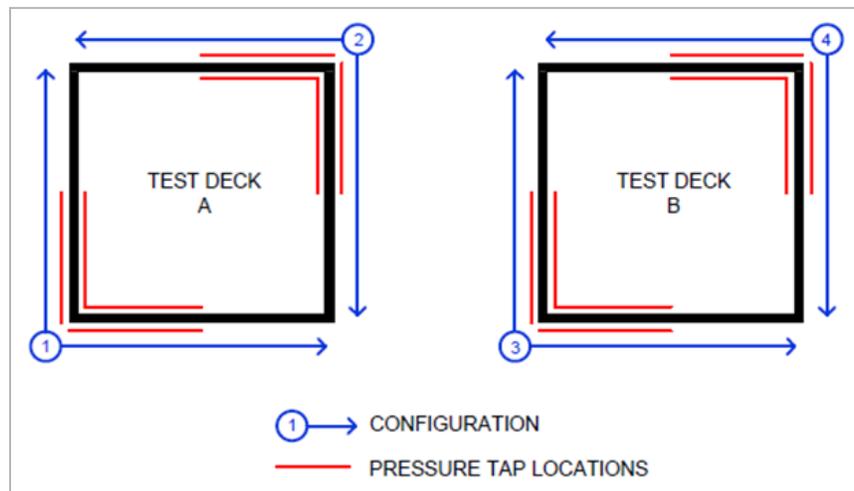
Overall, two test decks, each with 2 of the cleat-fascia configurations, were built. This figure provides a graphical representation of the 2 test decks with the 4 configurations.

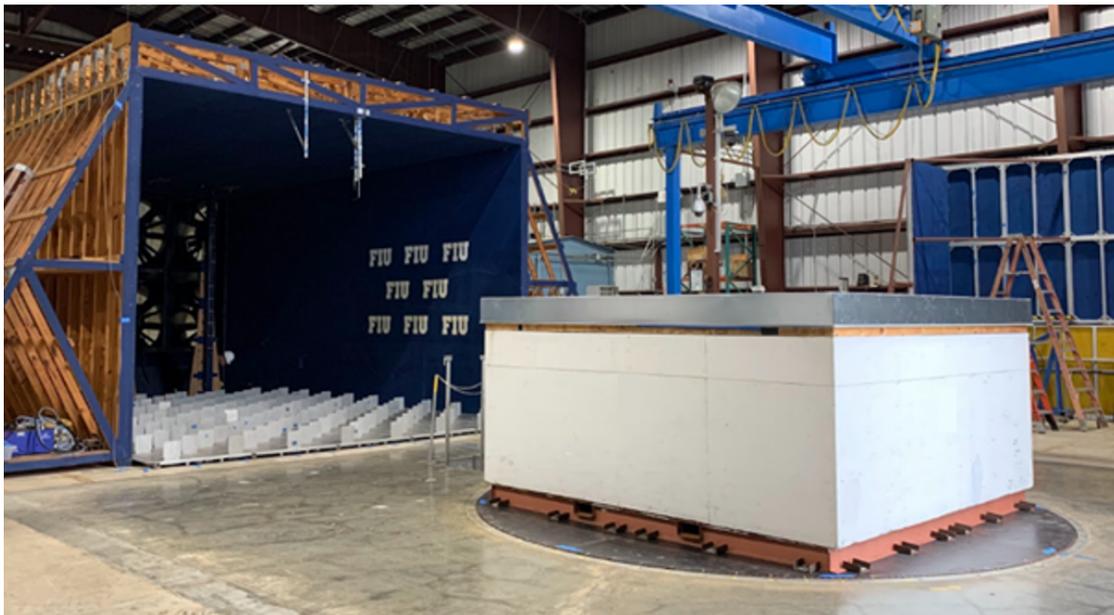
This photo shows one of the test decks in the wind tunnel.
